UNITED STATES AIR FORCE
AIRCRAFT ACCIDENT INVESTIGATION
BOARD REPORT

F-35A, T/N 15-5197

LOCATION: HILL AIR FORCE BASE, UTAH

DATE OF ACCIDENT: 19 OCTOBER 2022

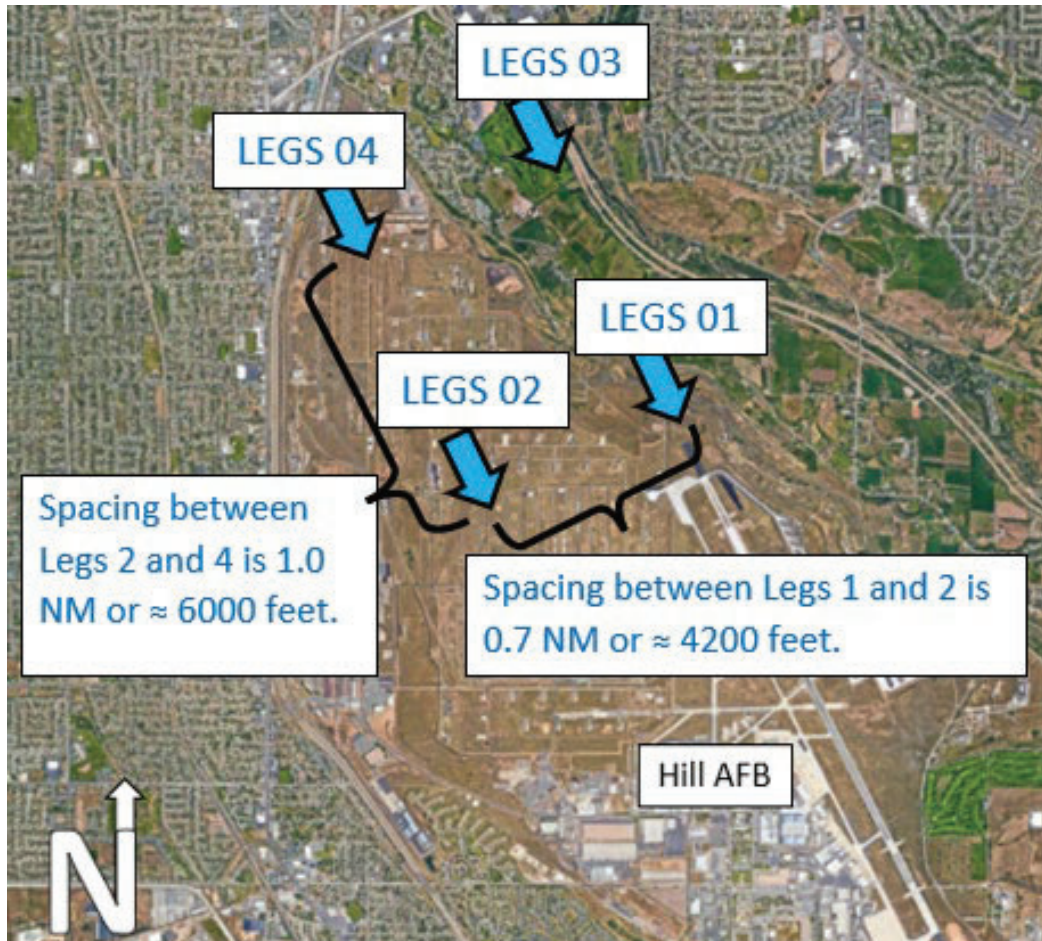
At 17:56:26, Legs 04 relayed the weather information to the MF (Tab CC-1.3). When Legs 04 relayed the weather, Legs 04 did NOT state that wake turbulence procedures are in effect (Tab CC-1.3). While Legs 04 should have relayed this information, based on the reported light winds, all pilots in the MF should have known wake turbulence procedures were in effect and landing distances increased (Tab CC-1.3). Pilots are responsible for wake turbulence separation when maintaining visual separation or operating under visual flight rules (Tab BB-2.17).

Figure 1: Formation Spacing arriving at Hill AFB (Tab Z-2.1)

Legs 02 and Legs 03 were not aware wake turbulence procedures were in effect (Tabs V-1.1.4 and V-3.2.4). As the MF announced the intention to land, the Hill AFB Tower noted to the entire MF at 18:07:29L that the current winds were at 5 knots (TAB CC-1.3). This is enough information for all pilots in the MF to know they must increase pattern and touchdown spacing in accordance with wake turbulence procedures (Tab CC-1.3). Legs 02 set the normal spacing (3,000 ft) behind Legs 01 (Tab V-3.2.3). According to available data, Legs 02 was approximately 5,000-6,000 ft behind Legs 01 (Tab CC-1.3). Legs 01 and Legs 02 did not encounter any wake turbulence or atmospheric disturbances and landed uneventfully (Tabs V-3.2.3 to V-3.2.4, and CC-1.3).

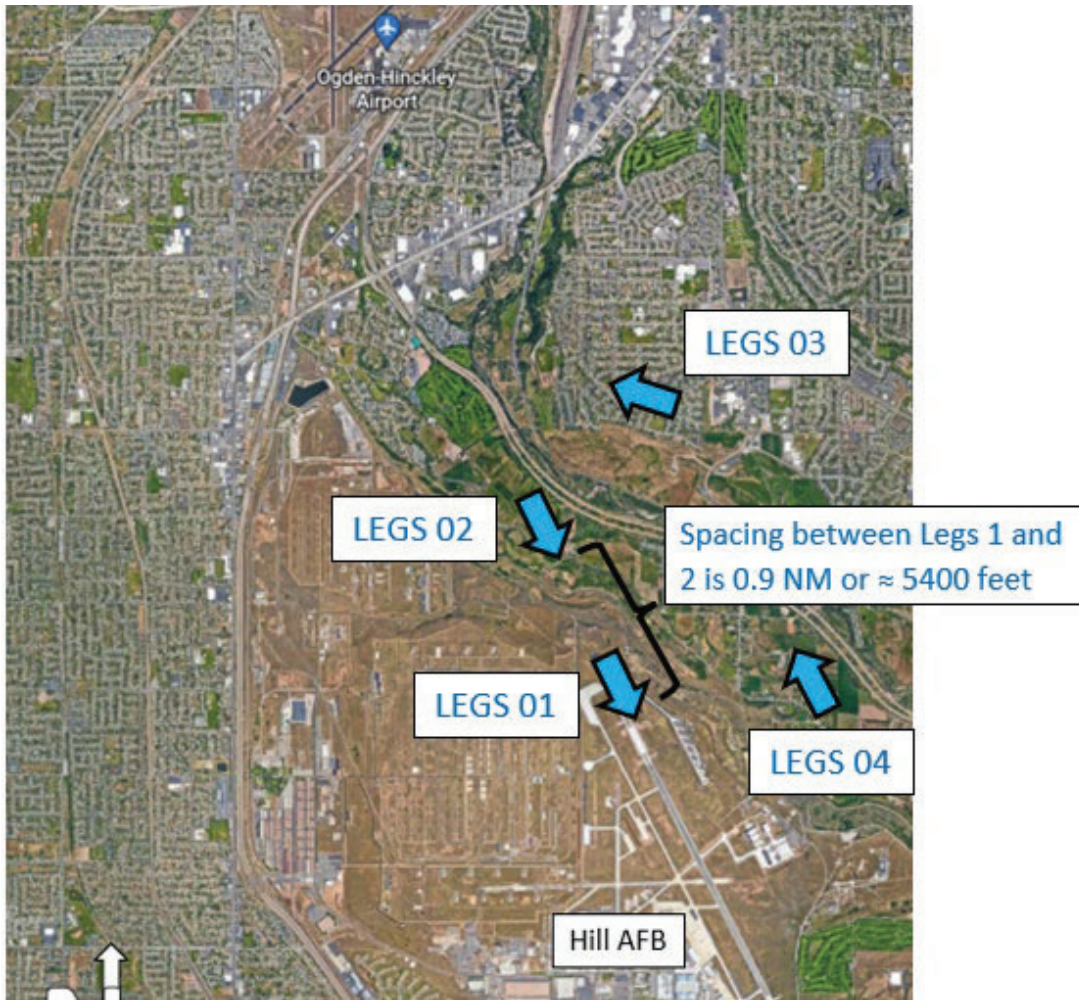
Figure 2: Approximate Aircraft Spacing at Legs 01 Touchdown (Tab Z-3.1)

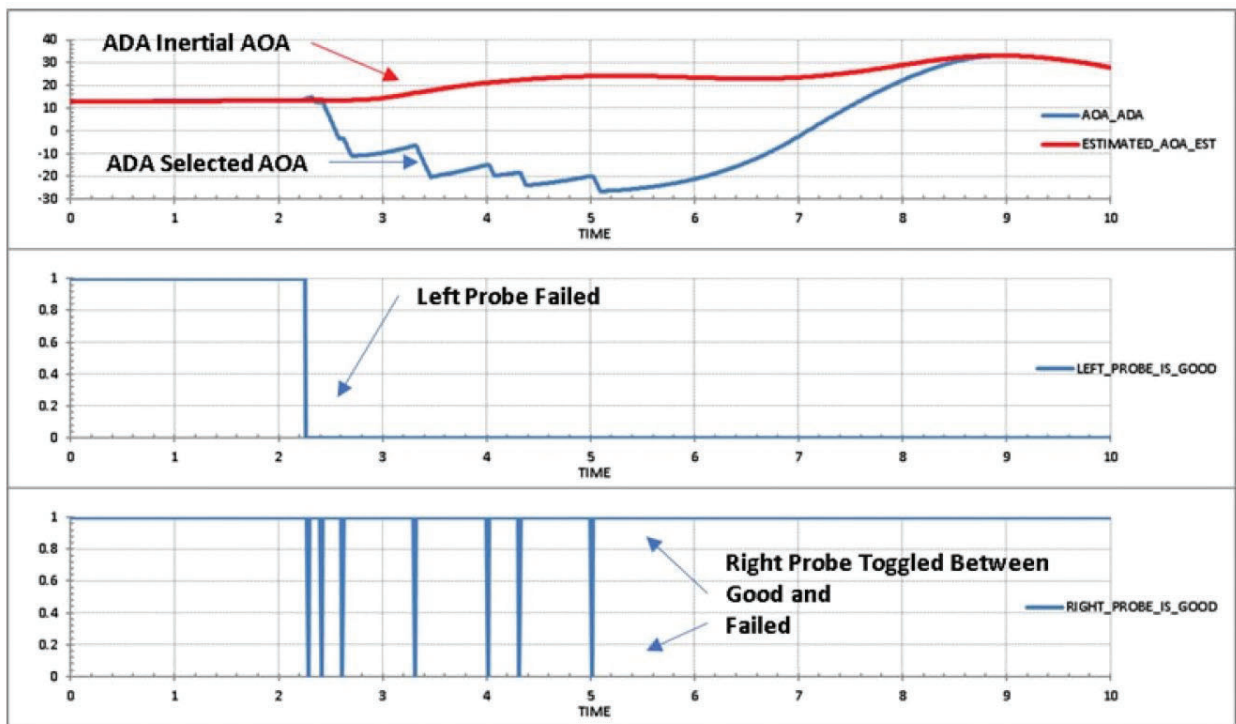
Each time the right probe was intermittently excluded, the ADA switched between primary and back up sources to determine flight conditions (Tabs J-1.29 and V-2.1.5). With each transition, a value referred to as a “sump,” was added to the on-board model to smooth flight control movements while switching between primary and backup (Tabs J-1.29 and V-2.1.7). “Sump” values nominally decay over four seconds, assuming there is a single transition between sources (Tab J-1.30). During the right probe’s multiple, short-duration, readings outside of input limits, the ADA switched between primary and backup sources multiple times without time for the sump value to decay (Tab J-1.30). Each time this transition occurred the sump values added together (Tab J-1.30). The sum of the sump values from the multiple transitions resulted in the on-board model’s estimation of aircraft conditions, differing from the aircraft’s actual conditions to the point the MP was no longer able to control the MA (Tabs J-1.30 and CC-1.2). Based on CSMU data, the aircraft was not correctly responding to pilot inputs in the final seconds prior to ejection and departed controlled flight at 18:08:34 (Tab CC-1.2). This data is evidenced in the angle of sideslip (AOSS) values at 18:08:34 and after, approximately 2 seconds prior to MP ejection at 18:08:36L (Tabs J-1.15, J-1.22, and CC-1.2).

Figure 17: Post Flight Analysis Simulation of ADA divergence (Tab J-1.31)

The control laws of the F-35 rely on receiving accurate air data, and with the on-board model predicted flight conditions and the physical flight conditions differing by more than 40 degrees, the flight control surface commands generated by the CLAW were incorrect for the current conditions (Tab J-1.31 to J-1.32).`

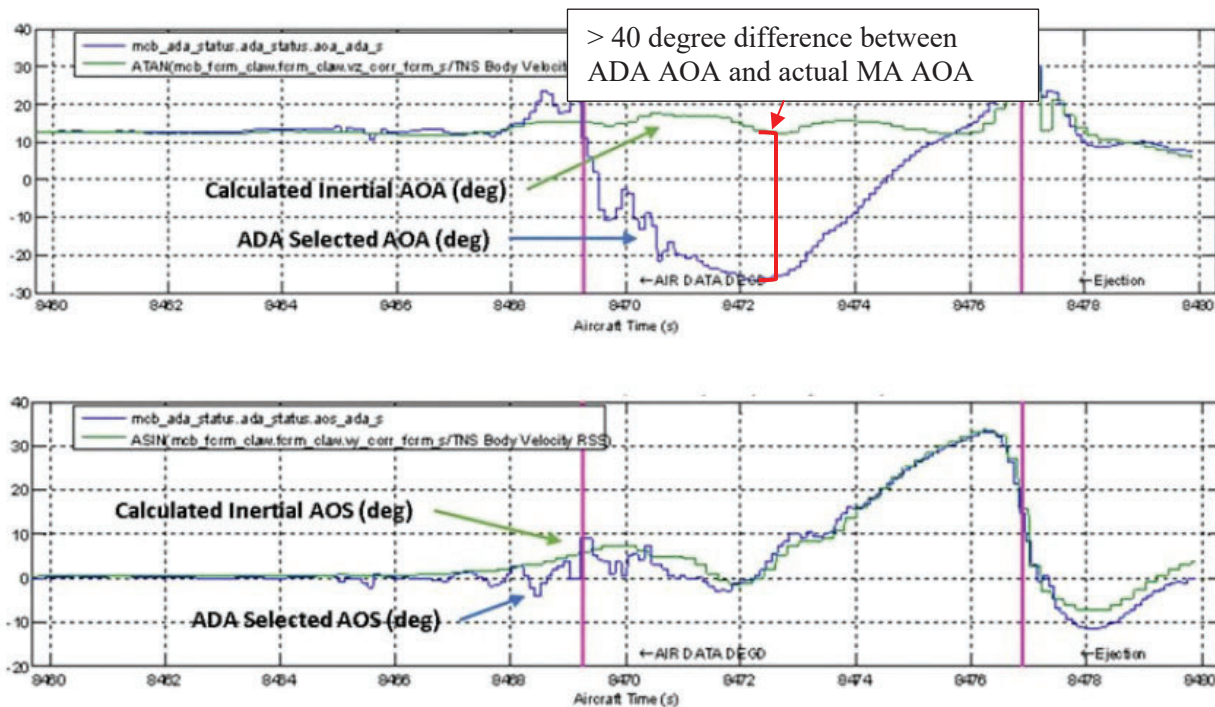
As captured by the CSMU, the disturbed air also caused the right-side probe to show readings outside input limits (Tab J-1.29). These readings did not trigger any ICAWs (Tab J-1.29). This intermittent disruption to the right side occurred multiple times over the next three seconds (18:08:27L to 18:08:30L) (Tab J-1.29). During each of these intermittent disruptions to the right side, with the left side inputs still excluded, the ADA stopped using primary readings until the right probe's readings came back to within acceptable parameters (Tabs J-1.29 and V-2.1.5).

Figure 18: CSMU Recorded Evidence of ADA divergence (Tab J-1.26)

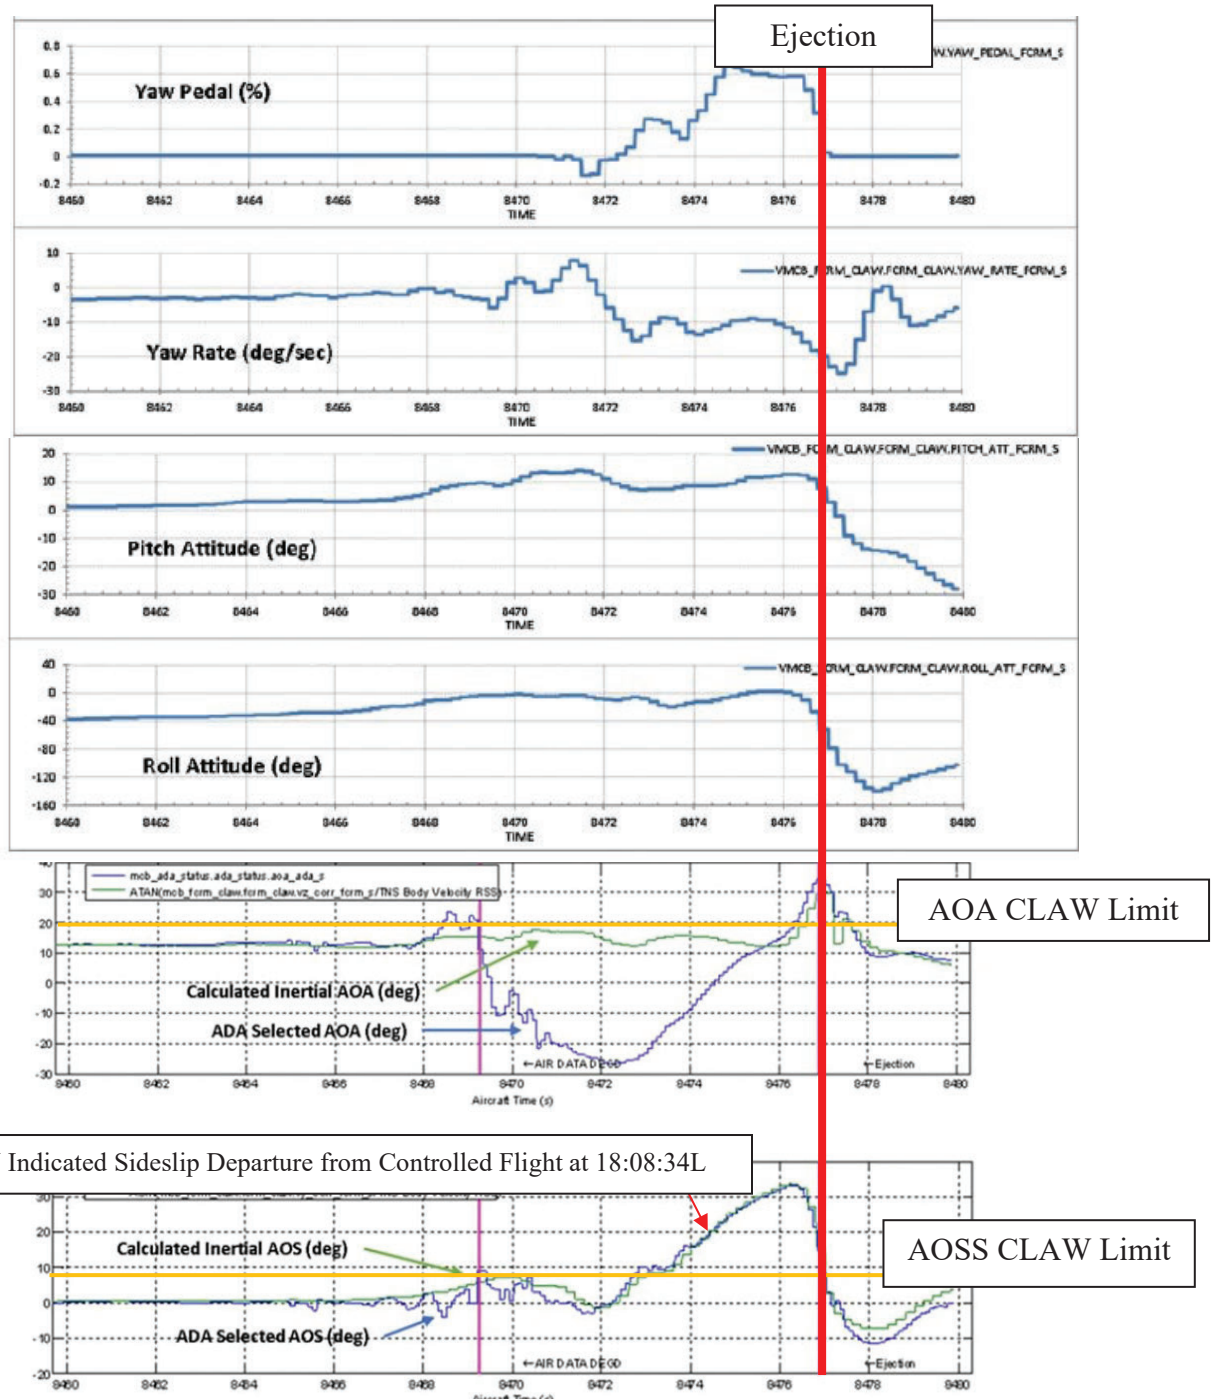
The following technical charts from the CSMU validates witness testimony, demonstrates the impact of the erroneous data supplied by the ADA, and verifies that the MA was out of control at the time the decision to eject was made (Tabs J-1.15, J-1.74, V-1.1.6, V-2.1.3, and CC-1.2).

Figure 19: MA Parameters prior to 2nd Disturbed Air through Impact (Tabs J-1.21 and J-1.26)
