UNITED STATES AIR FORCE
AIRCRAFT ACCIDENT INVESTIGATION
BOARD REPORT

F-35A, T/N 15-5197

LOCATION: HILL AIR FORCE BASE, UTAH

DATE OF ACCIDENT: 19 OCTOBER 2022

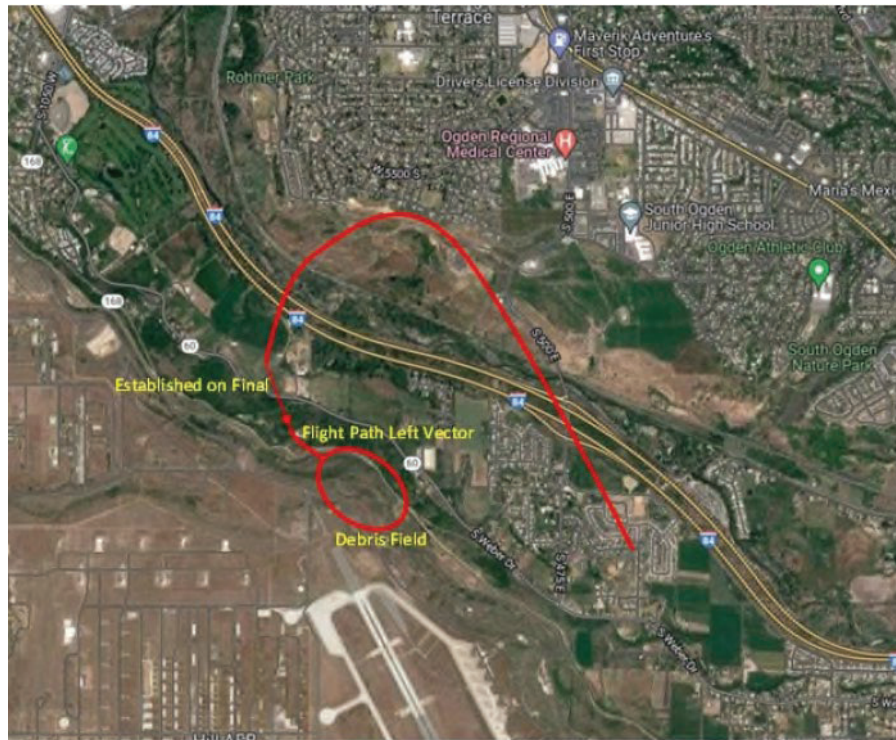
The MP ejected at approximately 18:08:36L, the MA continued into the terrain just north of the approach end of RWY 14 at Hill AFB in full afterburner with the left wing striking the ground first (Tab J-1.22 and J-1.48).

Figure 8: MA approach to attempt landing (Tab J-1.10)

The debris field fanned out with most of the aircraft disintegrating within airfield boundaries (Tab J-1.9). Parts of the cockpit, canopy and ejection seat were located just outside the airfield boundary fence line (Tab J-1.9).

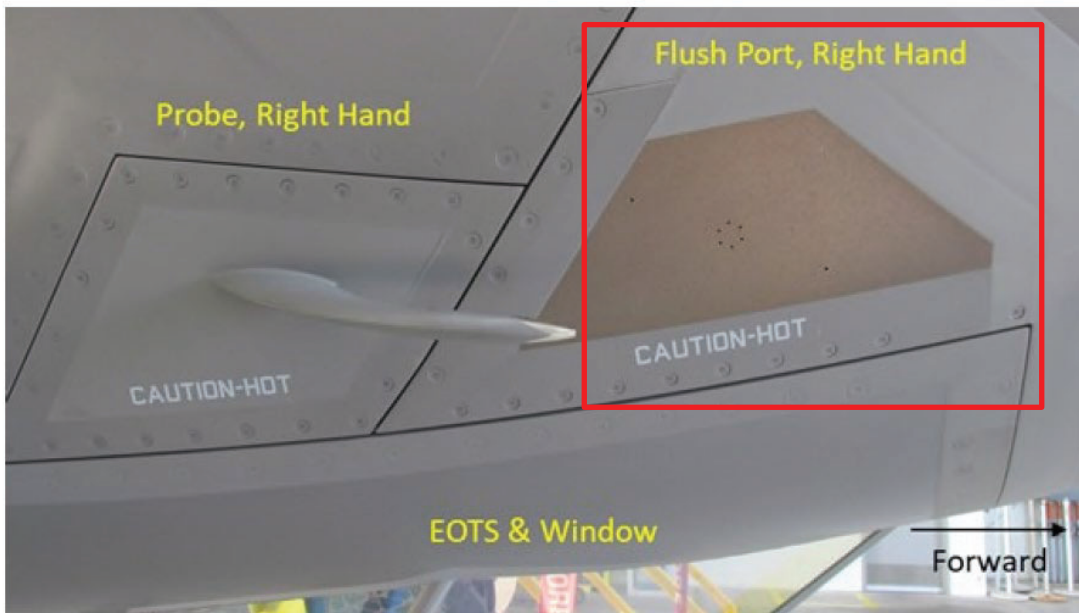
Air Data System (ADS): The ADS consists of sensors that collect information from outside of the aircraft and feed it into the ADA for use by other systems and the pilot (Tab CC-1.2). The F-35 ADS consists of one left hand and one right hand multi-function probe (MFP), and one left hand and one right hand flush port module (Tab J-1.39). The left-hand side and right-hand side are mirror images (Tab J-1.39).

Figure 14: Flush Port (Tab J-1.39)

During both events, simultaneous pressure disturbances were observed on all ADS MFPs and flush port sensors resulting in fluctuations of the ADA output parameters (Tab J-1.8).

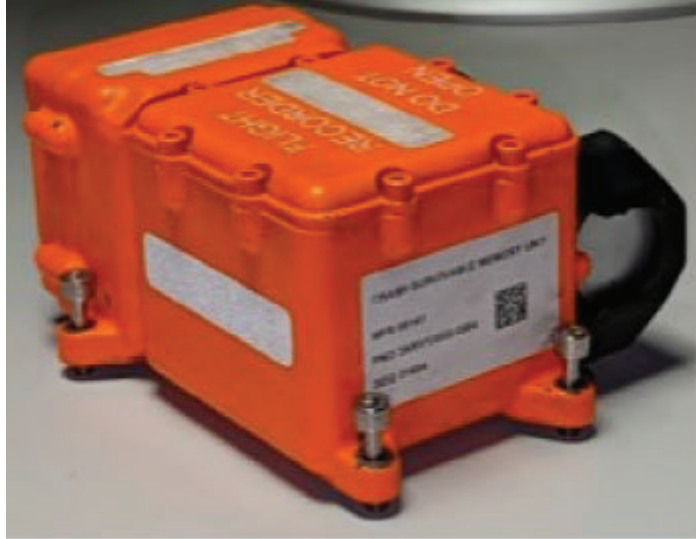
Crash survivable memory unit (CSMU): The CSMU is designed to survive a catastrophic crash and acts as a flight data recorder (Tab J-1.11). The CSMU from the MA was retrieved successfully (Tab J-1.24). The CSMU begins recording data at engine start (or when external power is applied to aircraft) and records continuously through the mission (Tab J-1.11).

Figure 16: F-35 CSMU (Tab J-1.13)

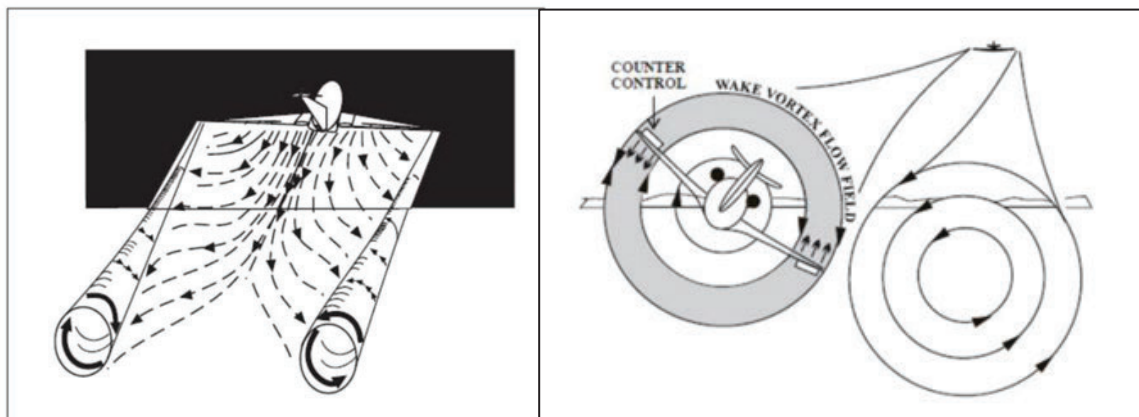
Every aircraft generates wake turbulence while in flight (Tab BB-7.1). Wake turbulence is a function of an aircraft producing lift, resulting in the formation of two counter-rotating vortices trailing behind the aircraft (Tab BB-7.1). Wake turbulence from an aircraft can affect other aircraft due to the strength, duration, and direction of the vortices (Tab BB-7.1). Pilots should always be aware of the possibility of a wake turbulence encounter when flying through the wake of another aircraft and adjust the flight path accordingly (Tab BB-7.1).

Figure 20: Wake vortex generation and impact on trailing aircraft (Tab BB-7.1 to BB-7.2)

Wake turbulence procedures at Hill AFB are intended to reduce the likelihood of following aircraft from entering wake turbulence vortices with the primary danger being an unexpected rolling motion close to the ground due to flight within the vortex, not because of an impact to the air data system of the F-35 (Tab CC-1.1 to CC-1.2). Most F-35 pilots interviewed for this investigation and the accident investigation board's F-35A Pilot Member, regularly experience wake turbulence while flying the aircraft (Tab CC-1.2). The F-35 has over 600,000 flight hours and this is the first known occurrence of wake turbulence having a catastrophic impact on the Air Data System (Tabs V-2.1.6 and CC-1.2).
